**Flood Control Project Maintenance
Levee Inspections**

Fall 2009 Levee Maintenance Deficiency Summary Report

San Joaquin River Basin

Reclamation District No. 2101 Blewett

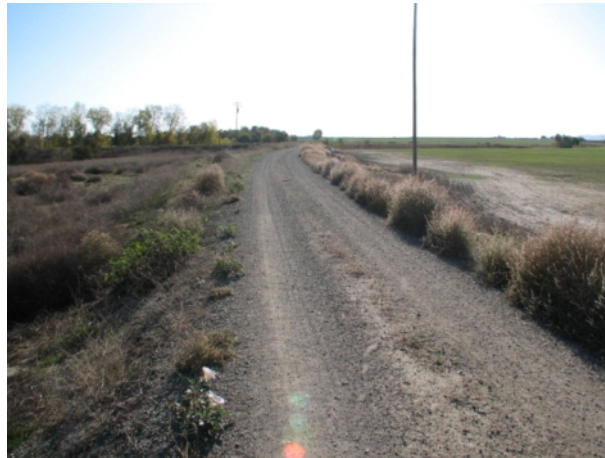
Levee Mile Report Line	3
Start Levee Mile	0.09
End Levee Mile	0.21
Location	Land Side
Category	Earthen Levee
Item	Vegetation

3	0.09	0.21	Earthen Levee	Vegetation	LS	M	Remove the wild growth other than native grasses from the levee slopes.	37.657696 ° -121.253099 °	37.657234 ° -121.251512 °	947 Y
4	0.17	0.17	Earthen Levee	Animal Control	CR	M	No rodents visible, but rodent burrows visible; need to backfill and compact or grout borrows.	37.656892 ° -121.252109 °	37.656892 ° -121.252109 °	948
5	0.23	2.01	Earthen Levee	Trim / Thin Trees	WS	M	Trim and thin trees to allow visibility of the ground and room to flood fight. Inspector Comments: In the past Department of Fish and Game did not allow this RD to touch WS vegetation. No removal has been planned in response to DFG policies. During inspection Fish & Game stated they would now allow vegetation maintenance on water side.	37.657200 ° -121.251437 °	37.649872 ° -121.227952 °	5 Y
6	0.27	0.32	Earthen Levee	Vegetation	LS	C	Remove the wild growth other than native grasses from the levee slopes.	37.657760 ° -121.250752 °	37.658184 ° -121.249946 °	949

Vegetation on land side slope of the levee near the crown obstructs visibility.

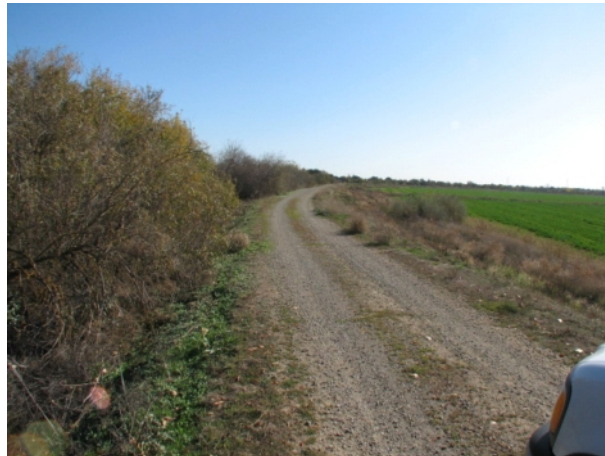
Levee Mile Report Line	5
Start Levee Mile	0.23
End Levee Mile	2.01
Location	Water Side
Category	Earthen Levee
Item	Trim / Thin Trees

Trees on top 20-ft of waterside slope block access and visibility.

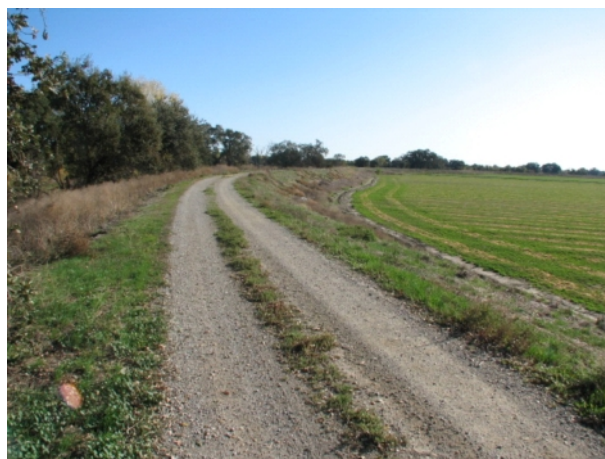
Levee Mile Report Line	7
Start Levee Mile	0.76
End Levee Mile	1.80
Location	Land Side
Category	Earthen Levee
Item	Encroachments

7	0.76	1.80	Earthen Levee	Encroachments	LS	PO	Agricultural Ditch	37.659827 ° -121.243675 °	37.651049 ° -121.231475 °	944 Y
8	1.18	1.18	Earthen Levee	Encroachments	WS	M	Tree or limb	37.654722 ° -121.240698 °	37.654722 ° -121.240698 °	950
9	1.35	1.35	Earthen Levee	Vegetation	CR	M	Elderberries are blocking visibility and flood fight capability.	37.653066 ° -121.238162 °	37.653066 ° -121.238162 °	951
10	1.40	1.40	Earthen Levee	Crown Surface / Depressions / Rutting	WS	M	Inspector Comments: Several lateral cracks have appeared on levee crown.	37.652835 ° -121.237586 °	37.652835 ° -121.237586 °	952 Y
11	1.91	2.00	Supplemental	DWR Erosion Survey	WS	U	Inspector Comments: 2009: recommend annual assessment and monitoring of critical erosion site, per CLRO CES Evaluation 2008 Report; site # same as RM76.3, LM1.89; previously rated "U" [2009 SiteID:RD2101U1RM73.92]	37.650259 ° -121.228961 °	37.650259 ° -121.228961 °	1

Cement lined ditch is within 10-ft of the landside levee toe. Section of levee in photo failed in 1997-1998.

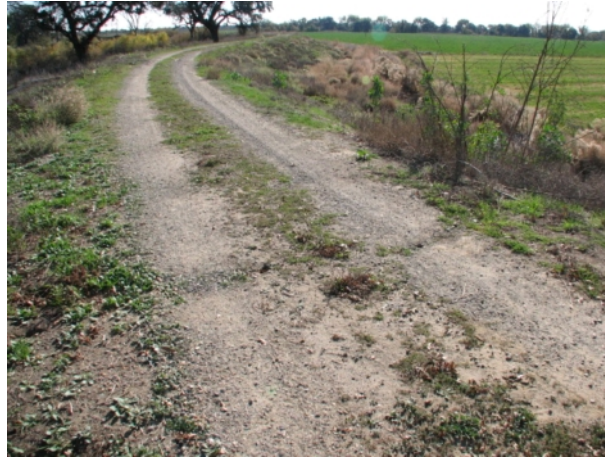
Levee Mile Report Line	10
Start Levee Mile	1.40
End Levee Mile	1.40
Location	Water Side
Category	Earthen Levee
Item	Crown Surface / Depressions / Rutting
One of several latitudinal cracks across the levee crown.	
jpaasch_20091116_204.jpg

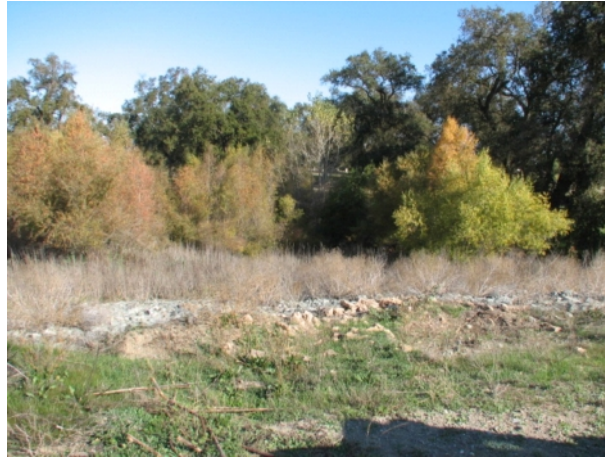
Levee Mile Report Line	1
Start Levee Mile	0.31
End Levee Mile	0.31
Location	Water Side
Category	Earthen Levee
Item	Erosion / Bank Caving

LMR No	Levee Mile		Category	Item	Location *	Rating **	Action/Comment	GPS Latitude/Longitude		Issue No.
	Start	End						Start	End	Photo
1	0.31	0.31	Earthen Levee	Erosion / Bank Caving	WS	M	Schedule repair of erosion site prior to the next inspection. Inspector Comments: Issue #2 RD 2101. At the end of this spur two rivers converge and due to past high water events a large scour hole has been formed. It is now filled in with vegetation. The next HW event could further scour this large hole.	37.663998 ° -121.242925 °	37.663998 ° -121.242925 °	2 Y

Fall 2009 photo of scour hole located at end of the spur levee.
